INDOOR AIR QUALITY ASSESSMENT

**Mary A. Dryden Memorial Elementary School
190 Surrey Road
Springfield, Massachusetts**

Prepared by:
Massachusetts Department of Public Health
Bureau of Environmental Health Assessment
Emergency Response/Indoor Air Quality Program
July 2003

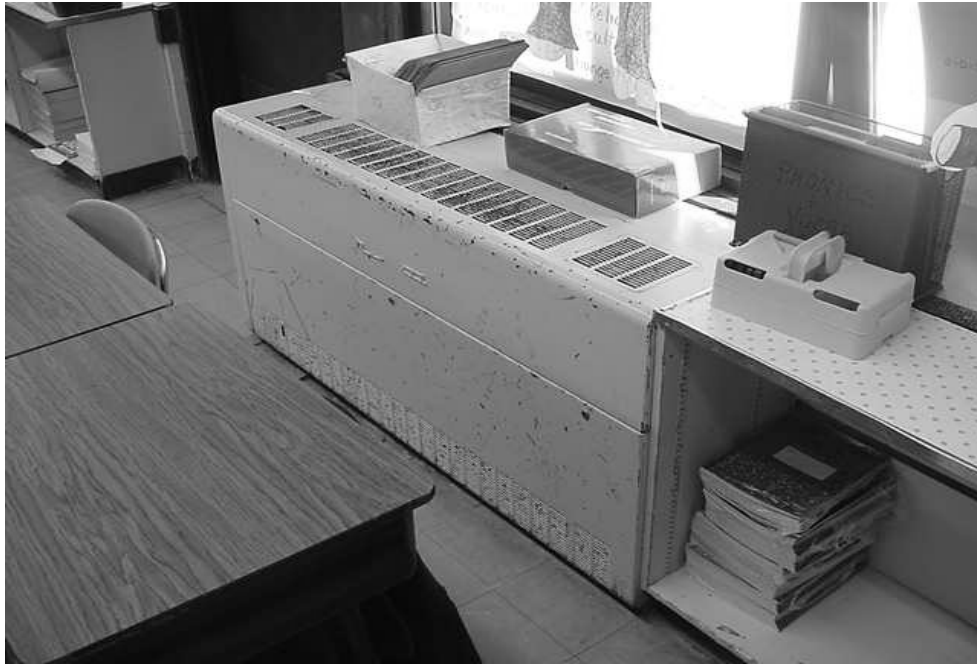
Picture 1

Fresh air in classrooms is supplied by a unit ventilator (univent) system (see Picture 1). Univents are designed to draw air from outdoors through a fresh air intake located on the exterior wall of the building and return air through an air intake located at the base of each unit (see [Figure 1](#)). Fresh and return air are mixed, filtered, heated and provided to classrooms through a fresh air diffuser located on the front of the unit. As discussed, univents were found deactivated, preventing a continuous source of outside air. Obstructions to airflow into fresh air intakes by shrubbery were also noted (see Picture 2). In order for univents to provide fresh air as designed, univent air intakes, diffusers and return vents must remain free of obstructions. Importantly, these units must be activated and allowed to operate.

Univent

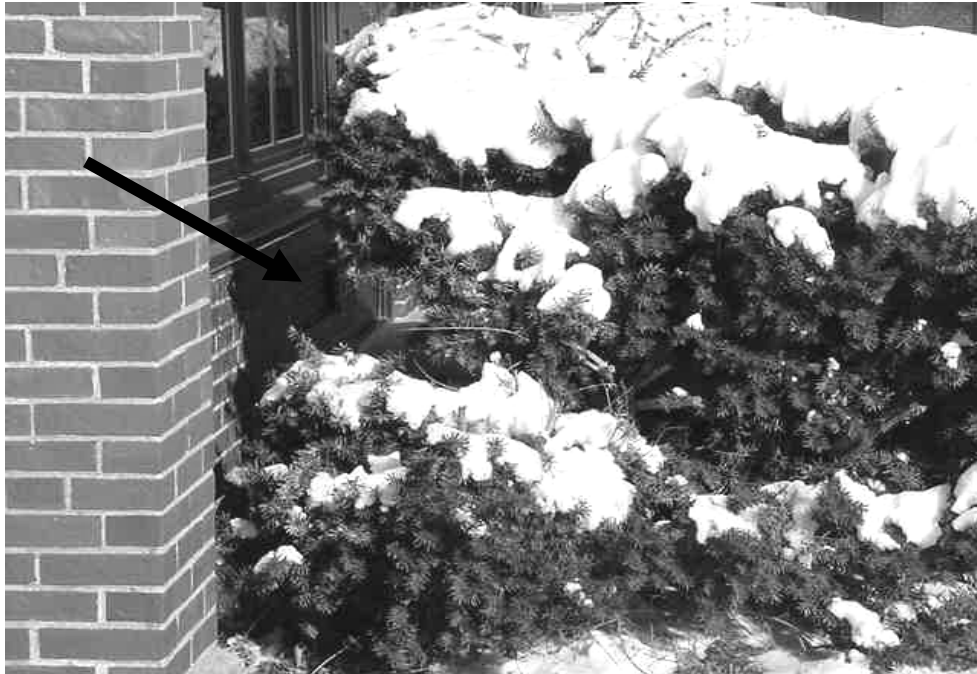
Picture 2

Shrubbery in direct contact with the exterior wall brick was noted along the front of the building (see Pictures 2, 4 and 5). Shrubbery directly against the building can serve as a possible source of water impingement on the exterior curtain. Plants retain water and in some cases can work their way into mortar and brickwork causing cracks and fissures, which may subsequently lead to water penetration and possible mold growth. Over time, this process can undermine the integrity of the building envelope and provide a means of water entry into the building through capillary action via foundation concrete and masonry (Lstiburek & Brennan, 2001).

equipped with drip pans. Plants should also be located away from univents to prevent the aerosolization of dirt, pollen or mold (see also Picture 2, shrubbery in front of outside air intake).

Shrubbery Obstructing Univent Fresh Air Intake

5. Remove plants from tops of univents. Ensure plants have drip pans. Examine drip pans periodically for mold growth and disinfect with an appropriate antimicrobial where necessary. Remove foliage to no less than five feet from the foundation/exterior walls.

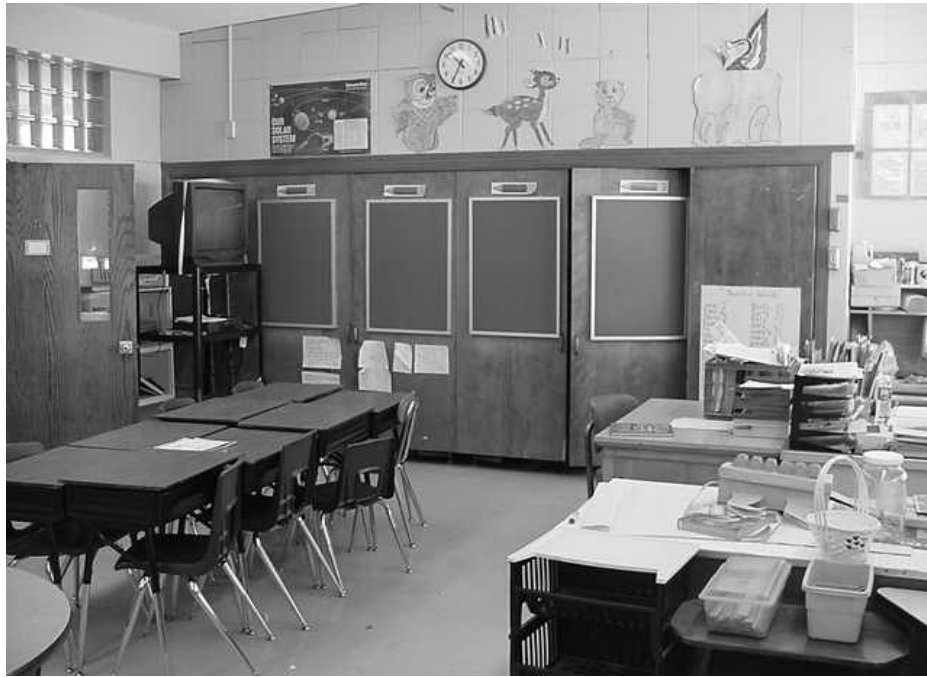
Picture 3

Exhaust ventilation grilles are located in the ceiling of coat closets. Air is drawn into the coat closet from the classroom via undercut closet doors (see Picture 3). The

location of these closet vents allows them to be easily blocked by stored materials. As with the univents, in order to function properly, exhaust vents must remain free of obstructions.

Exhaust Vent in Closet with Undercut Doors

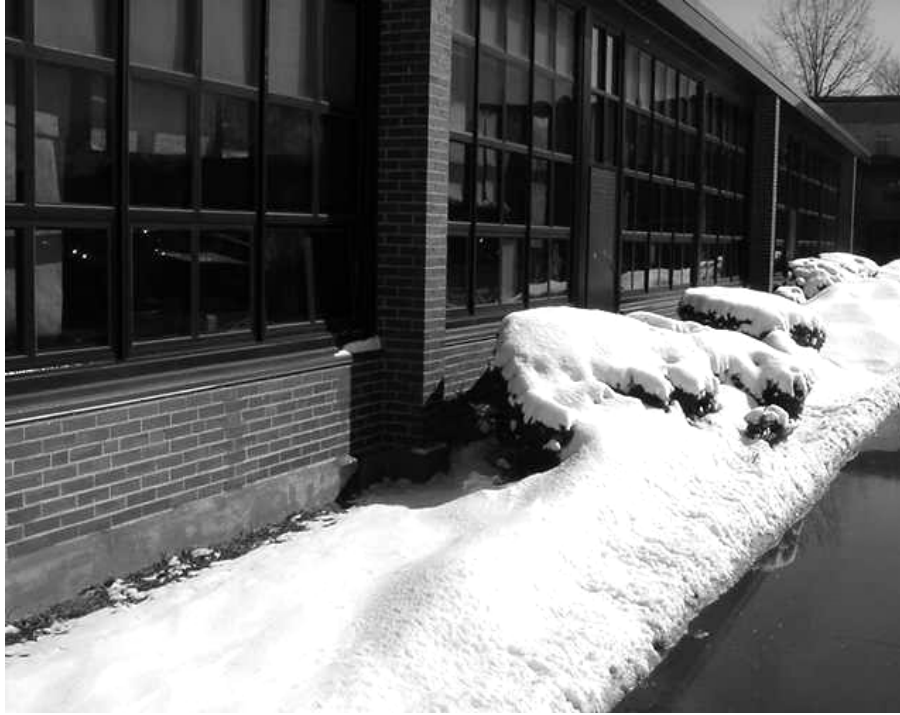
Picture 4

Shrubbery in Direct Contact with the Exterior Wall Brick Was Noted Along the Front of the Building

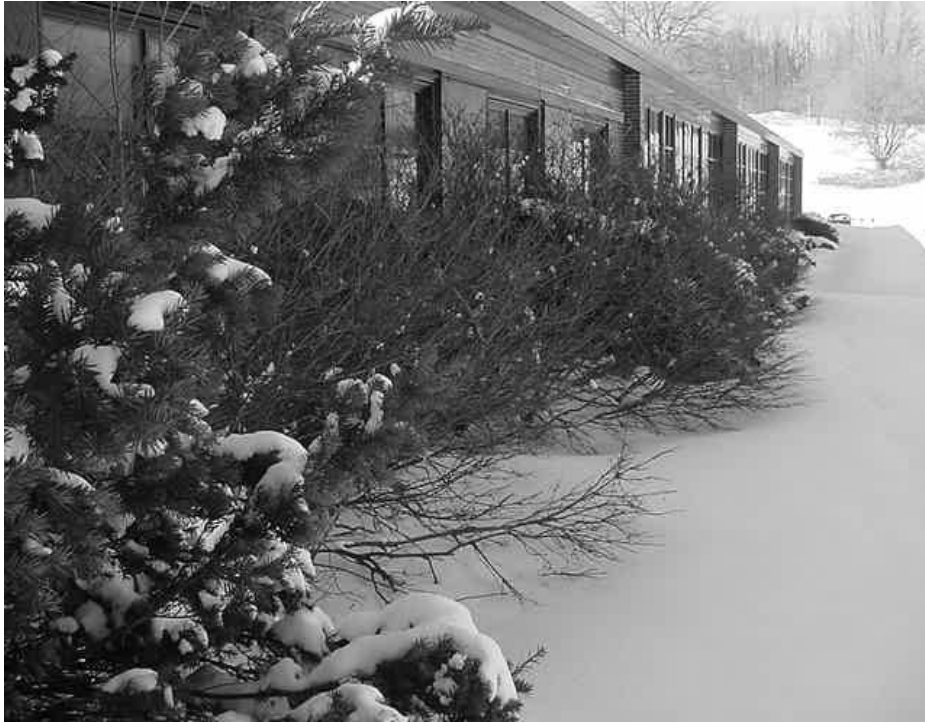
Picture 5

Shrubbery in Direct Contact with the Exterior Wall Brick Was Noted Along the Front of the Building

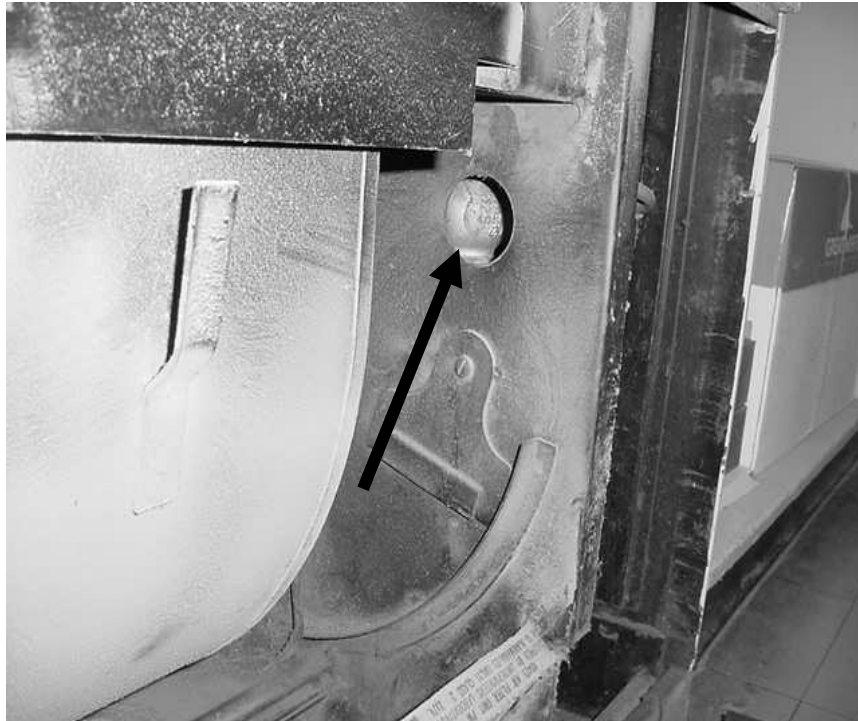
Picture 6

Several pathways exist for crawlspace air to migrate into occupied areas. A crawlspace exists under classrooms to provide a chaseway for univent heating pipes. The interiors of univents were randomly examined. Spaces and holes in walls and floors around pipes and within the air handling cabinet were observed (see Pictures 6 & 7). Please note that holes also exist in the rear wall of univents that open into the exterior wall system. These breaches can serve as pathways to draw air, odors and particulates from exterior wall cavities and the crawlspace into classrooms. Crawlspace access hatches located in classroom floors also provide potential pathways (see Picture 8). The seals around hatches appeared damaged. Heated air from HVAC system pipes can create drafts that rise from the crawlspace into classrooms around hatchways. These drafts can also draw mold, spores and associated odors from the crawlspace.

Holes within the Air Handling Cabinet

1. Seal all holes in the walls of the univent air handling cabinets to limit filter bypass.
Double sided, foil faced insulation with adhesive can be applied in a manner to create an airtight seal.

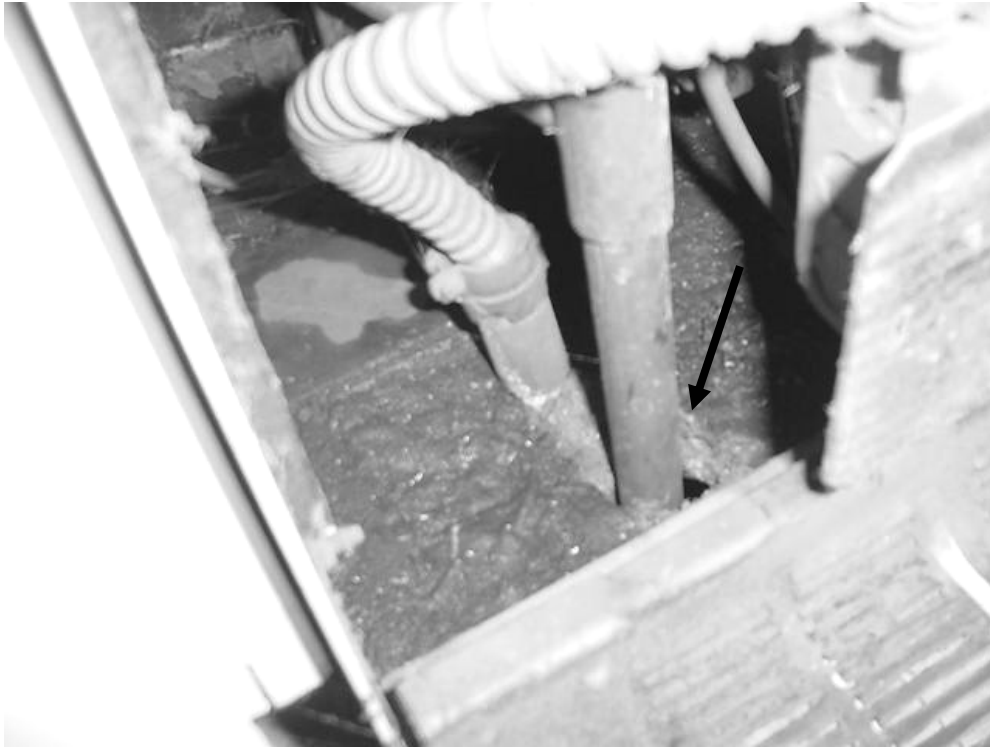
Picture 7

Holes Exist in the Floor for the Univent Heating Pipes

2. Seal walls in the rear of each univent cabinet and floor holes to prevent air draw from the exterior wall cavity and crawlspace, respectively. Seal the seams and holes in crawlspace access hatches with duct tape.

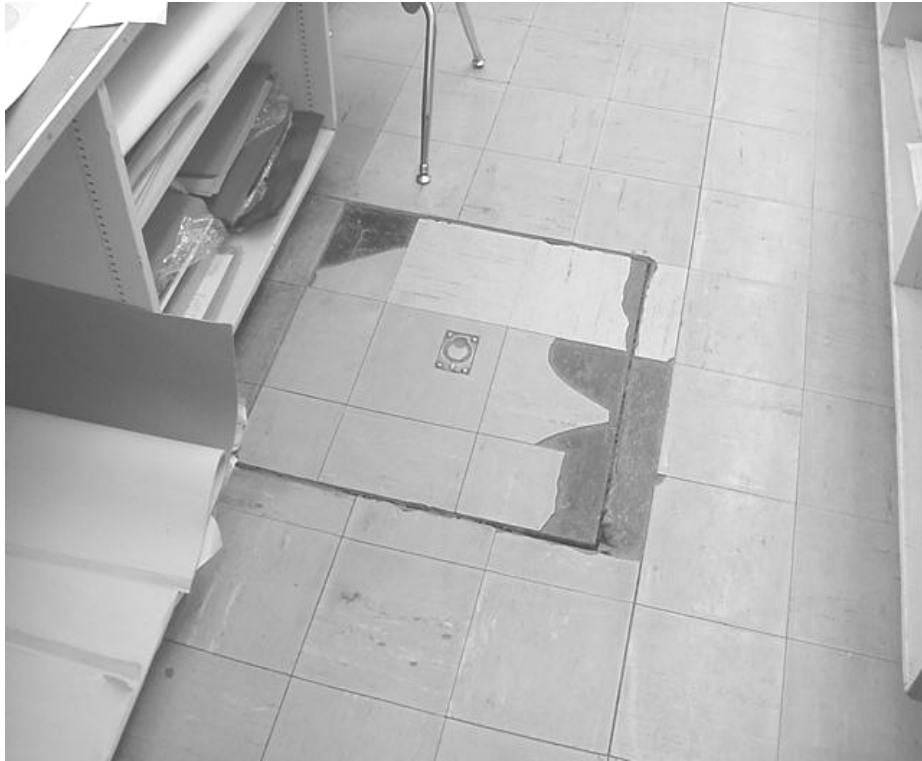
Picture 8

Crawlspace Access Hatches Located In Classroom Floors

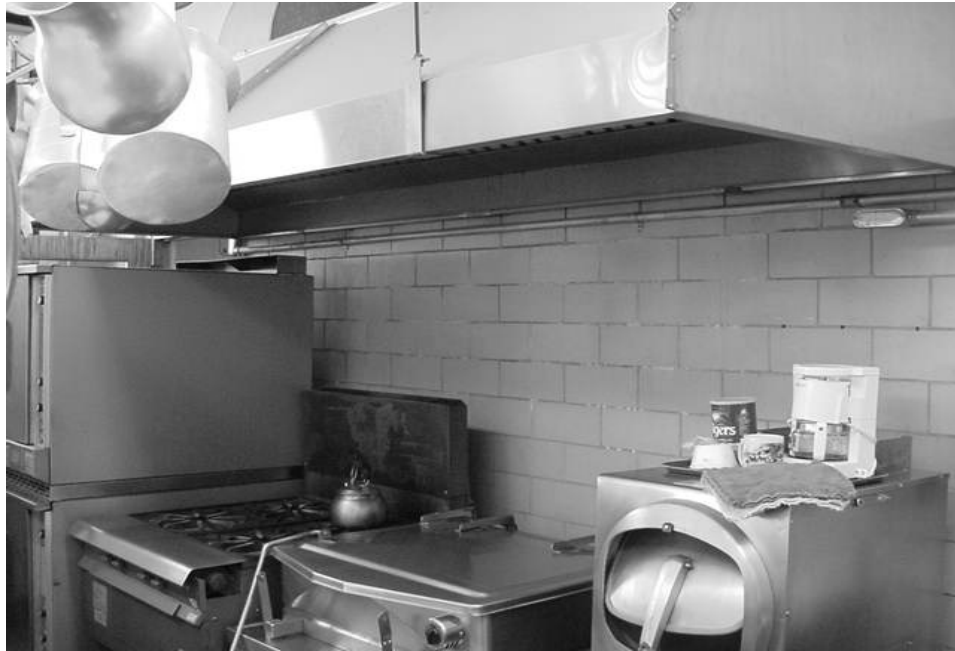
Picture 9

Several other conditions that can potentially affect indoor air quality were also identified. The kitchen contains a natural gas fueled oven (see Picture 9). According to the Massachusetts Building Code, “[s]tationary local sources producing airborne particulates, heat, odors, fumes, spray, vapors, smoke or gases in such quantity as to be irritating or injurious to health shall be provided with an exhaust system or means of collection and removal of contaminants” (SBBRS, 1997; BOCA, 1993). The vent to the oven was deactivated. Deactivation of the vent allows for products of combustion related to burning natural gas as well as products produced from heating/cooking food to accumulate in the kitchen, cafeteria and surrounding hallways. The process of combustion produces a number of pollutants, depending on the composition of the material. In general, common combustion emissions can include carbon monoxide, carbon dioxide, water vapor and smoke. Operation of the oven hood is essential to removing these pollutants from the indoor environment.

The Kitchen Contains A Natural Gas Fueled Oven
